MERRIMACK RIVER BASIN
LEOMINSTER , MASSACHUSETTS

PIERCE POND DAM
MA 00883

**PHASE I INSPECTION REPORT
NATIONAL DAM INSPECTION PROGRAM**

JUNE 1980

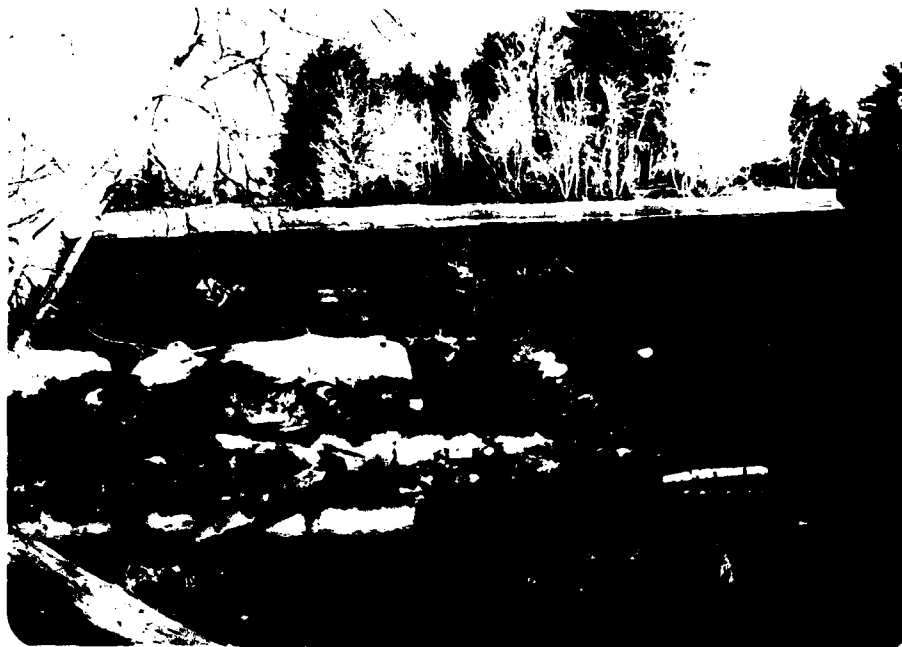
**NO. 3 SPILLWAY APRON AND DISCHARGE CHANNEL
(FEBRUARY 1980).**

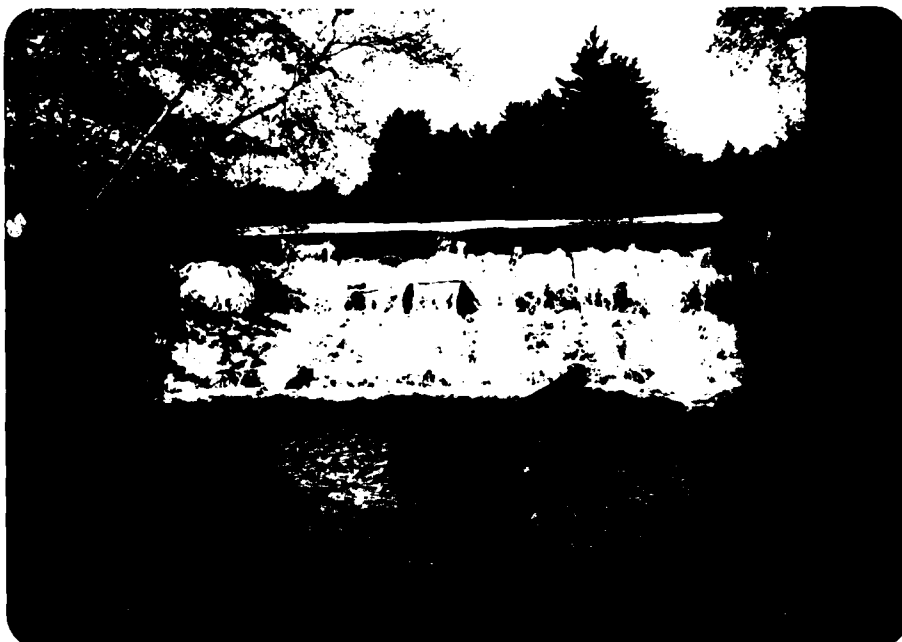
- e. Downstream Channel. (See Photo nos. 4 and 9). Both the spillway and outlet discharge into the downstream channel. The vertical stone masonry walls that form the sides of the channel are in good condition. Two clay drainage pipes are visible in the base of the channel walls, as shown on Figure B-1. Some flow was visible from the 4-inch pipe, on the right wall, and slight iron staining occurs on the rock and soil below it. There was no water flowing from the 10-inch pipe on the left wall, at the time of the inspection. The floor of the channel is covered with cobbles and boulders. Except for a few tree trunks, there is very little debris on the floor of the channel. Trees and brush are overhanging both sides of the channel. (see Photograph Nos. 9 and 10).

**NO. 4 SPILLWAY AND LEFT SIDEWALL, ADJACENT TO
FLUME AND WHEEL HOUSE (MAY 1980).**

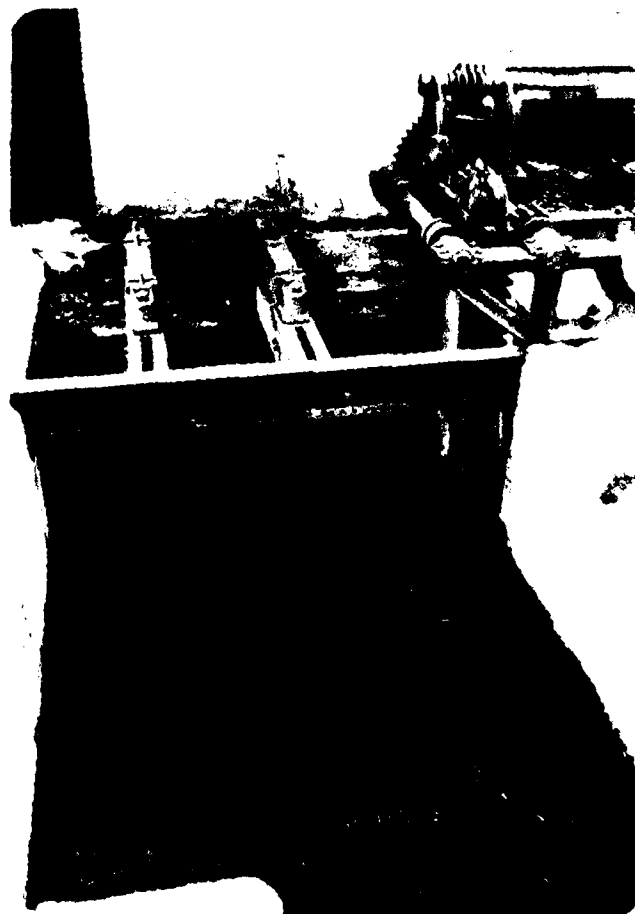
is not in operating condition, and parts of the operating mechanism are rusted and missing. The discharge end of the outlet is blocked by the slide gate, and although no flow was noted through the gate, a considerable amount of leakage occurs through the wall, in the vicinity of the outlet.

NO. 8 SLIDE GATE MECHANISM FOR LOW
LEVEL OUTLET.

- (2) Repair the operating mechanism on the outlet to restore it to working condition.
 - (3) To prevent continued erosion, fill in animal burrows and eroded areas on the upstream and downstream face of the earth embankment, and reseed.

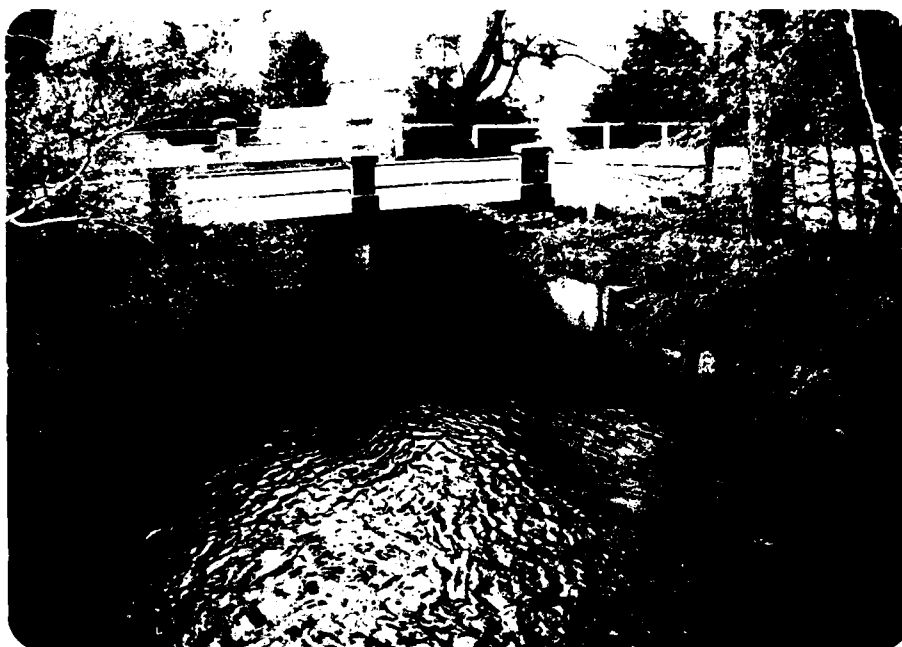
**NO. 9 SPILLWAY DISCHARGE CHANNEL AND LINDELL
 AVENUE BRIDGE.**

- (4) Replace missing riprap on the upstream face of the embankment.
 - (5) Remove tree trunks from the discharge channel.
 - (6) Institute a definite plan for surveillance of the dam and spillway during and after periods of heavy rainfall and a plan to warn people in downstream areas in the event of an emergency at the dam.
